The Beaufort Gyre Observing System 2004: Mooring Recovery and Deployment Operations in Pack Ice

Technical Report

WHOI-2005-05

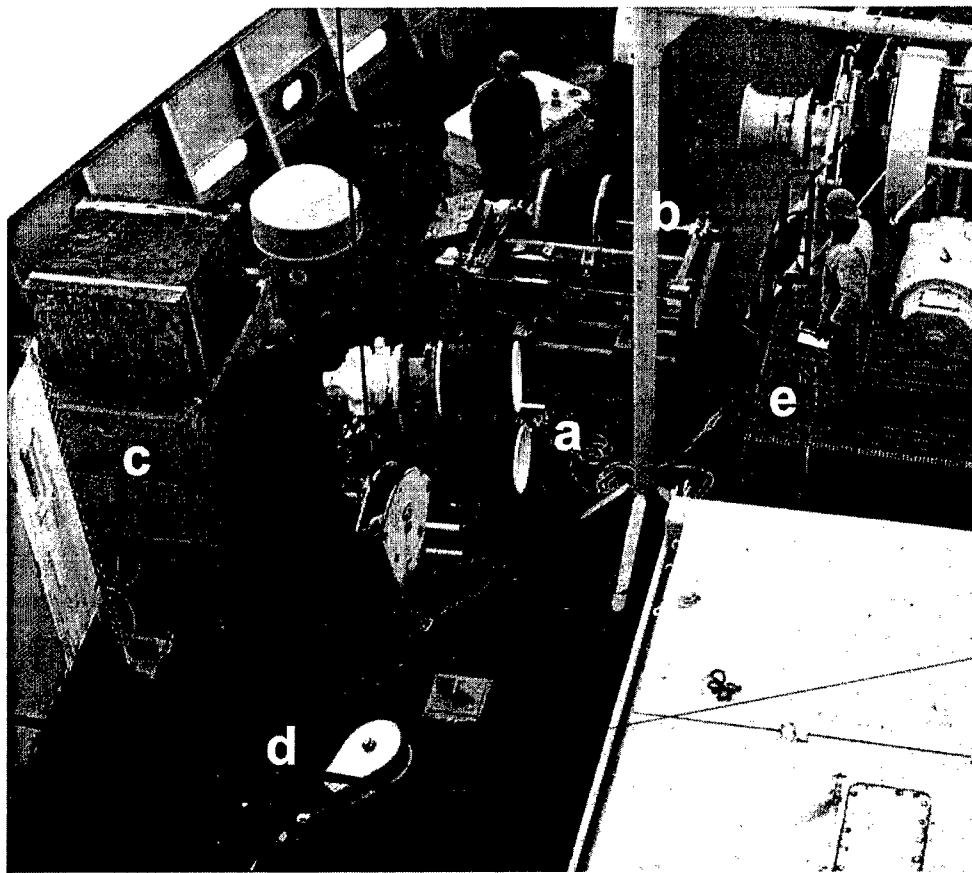
Figure 3. The Lebus traction winch system installed on the fore deck of the LSL: a) double barreled capstan, b) spooler winch, c) power pack, d) fairlead plate and block, e) remote control box.

Unlike most mooring operations conducted on UNOLS vessels where the mooring deployment and recoveries are performed from the stern of the vessel, mooring operations on the LSL are conducted from the foredeck of the ship. The work area is equipped with a starboard side A-frame and two stiff boom cranes located on either side of the foredeck, each capable of lifting heavy gear out of the water. The deployment cruise on the LSL in 2003 utilized the ships windlass to deploy the BGOS moorings, but this technique proved to be rather slow and labor intensive, and would be more so during recovery operations. Consequently, a special traction mooring winch system (manufactured by the Lebus company in England) and custom fairlead plate were installed on the ship for use in conjunction with the ship's cranes and A-frame in the recovery and re-deployment of the moorings in 2004 (Figure 3).

The capstan winch has two capstan barrels positioned horizontally one over the other. There are two fair lead gates located at the front and rear of the winch through

which the mooring wire enters and exits. The free end of the mooring wire is guided through the front fairlead gate (low tension side), wound around the two capstan barrels with typically 5 to 6 wraps, and passed out through the rear fair lead gate (high tension side). The axial ordination of the upper barrel is important in maintaining adequate separation between the wire wraps. The separation between each wrap can be adjusted by activating a manual hydraulic control pump that pivots the upper capstan barrel horizontally, causing the wire wraps to migrate towards the desired inner or outer edge of the barrels. The capstan winch is operated from a remote control box. This control box is fitted with an emergency stop button and a toggle control that allows the capstan barrels to operate at infinite speeds. The winch's operating capacity is 7000 lb at 30 fpm.

The spooler winch is a hydraulically powered reel stand that is controlled separately from the capstan winch. This winch is designed to support wooden wire and rope storage reels and to provide a haul in line tension up to 250 lb. The spooler winch should nominally maintain between 125 to 150 lb of back tension in order to keep the wraps tight on the capstan barrels. The spooler is generally positioned approximately 10 ft from the low tension side of the capstan winch. This is to allow for adequate working area between the two pieces of equipment in order to connect and disconnect wire and rope mooring segments. The capstan and spooler winches are powered by a 400 volt, 3-phase, 60Hz electric hydraulic power pack.

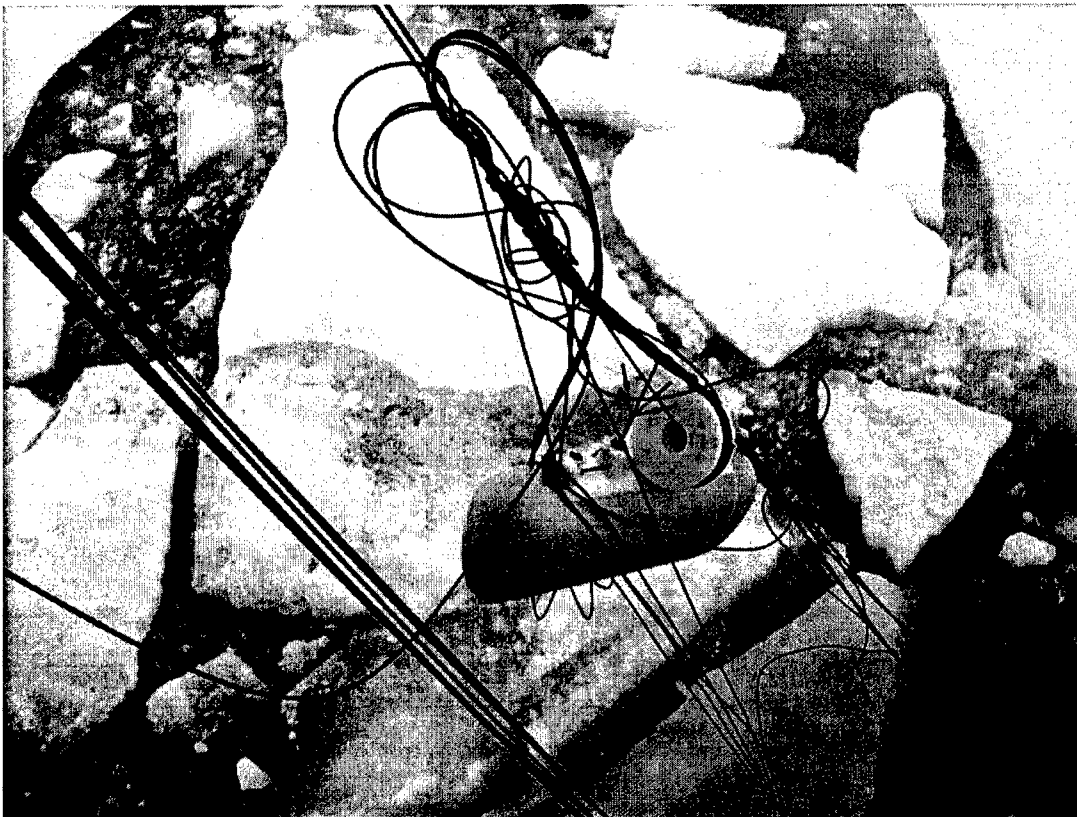
Figure 7. A particularly nasty entanglement of 9 wire rope segments during the recovery of the MMP on mooring C. Amazingly, the instrument was undamaged.

However, due to the backup flotation positioned at the bottom of each mooring and spring effect of the wire upon release, each mooring typically had some entanglements (wuzzles) in the wire rope which complicated the recovery. Where this occurred, the mooring had to be stopped off while portions of the wires were sorted and brought on deck (sometimes manually, at other times in bites using the vertical chain stopper, and once using the ship's windlass as a secondary winch). At times,

entanglements of more than 5 different shots of wire were shackled together and wound around the winch at once, while making sure that they did not tangle while passing through each block. Once most of the wire shots above the flotation spheres at the bottom had been recovered, the next task was to recover the spheres.

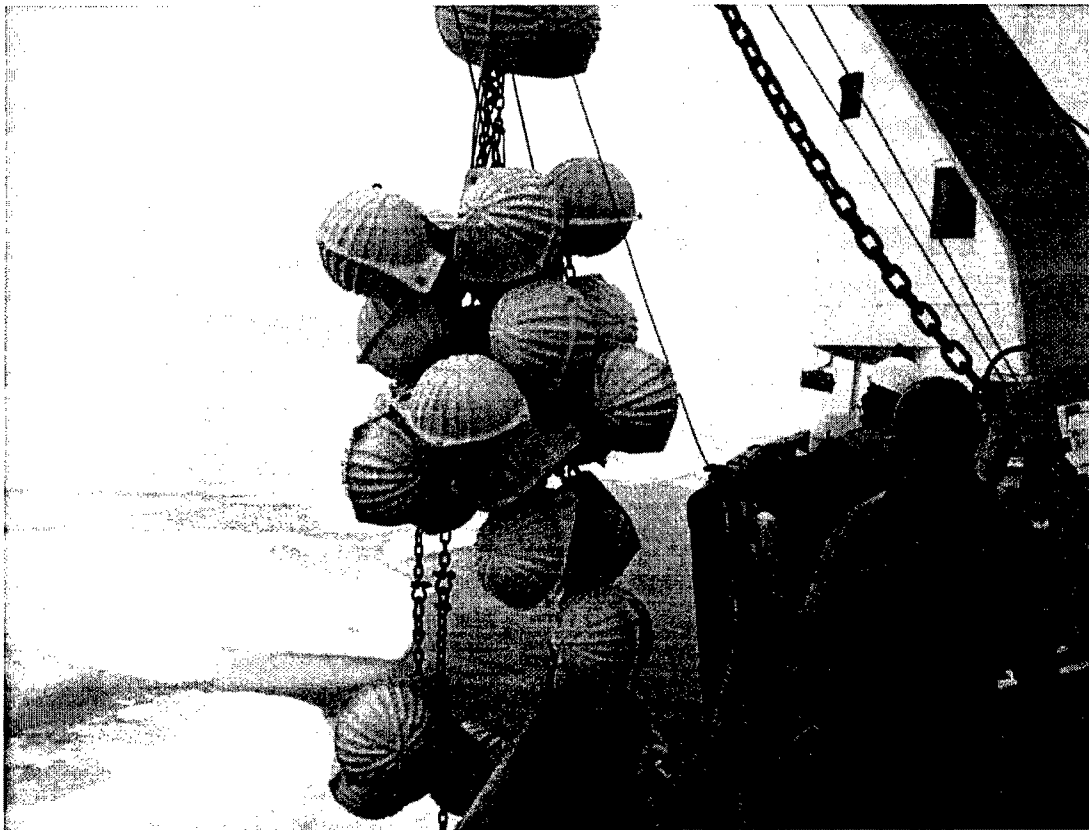
Figure 8. Cluster of glass floats comprising the backup buoyancy being recovered.

The glass spheres also snarled in large bunches (Figure 8) and sometimes were wedged just underneath the ice. In order to recover the spheres without putting too much strain on the wire, it was decided to slowly pay in the winch while the ship slowly traveled toward the direction of the wire. In other words, the captain went to the spheres instead of trying to pull the spheres to the ship. This method proved to be extremely effective and necessary in order to recover this section of the mooring safely. Because of the enormous snarls, the spheres were literally caught up in the ice and required a vertical lift instead of a horizontal drag.

When the floats were reached, an open-end recovery hook and steering tag line was used to attach to the cluster. The ship's crane was lowered, and the Boatswain hooked onto a link of chain, a shackle, or a pear ring, then raised the cluster to the A-frame. The vertical chain stopper was used to hook into a termination of wire below the balls in order to stop off the mooring so the floats could be disconnected and brought onto the deck.

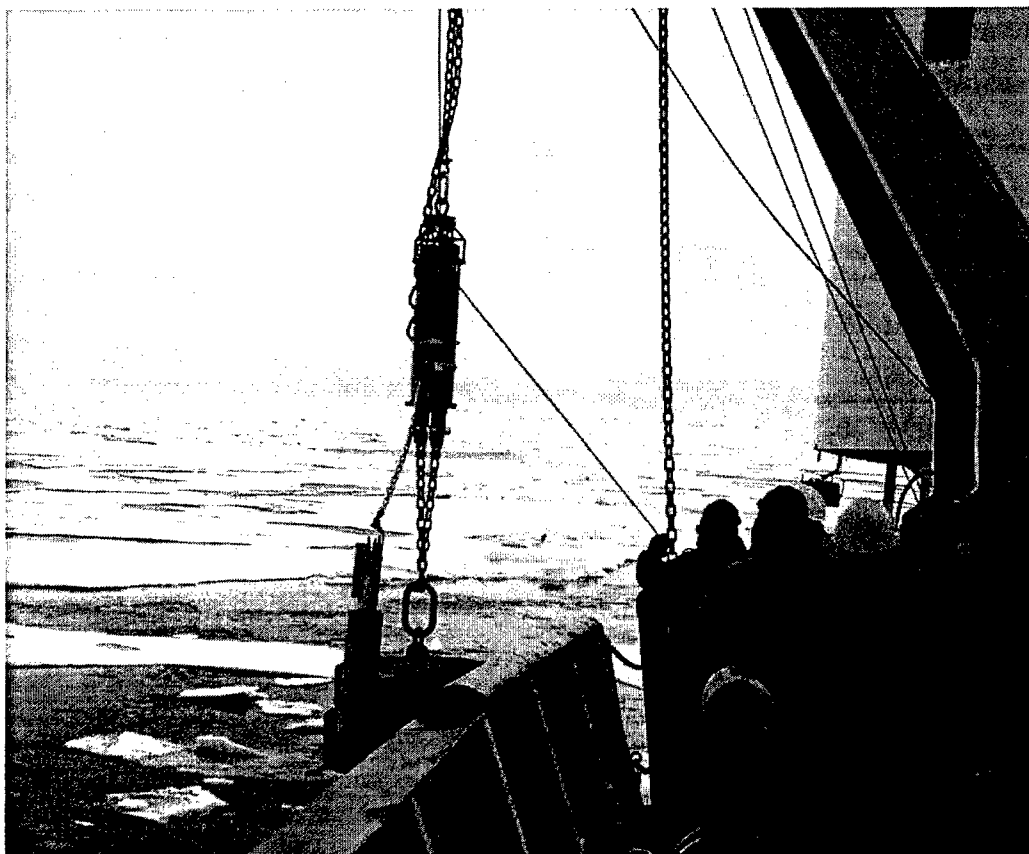
Figure 9. Lowering the anchor, BPR, and releases during anchor first mooring redeployment.

Each mooring was deployed anchor first using the Lebus winch. The first phase of each mooring deployment required the attachment of the dual Edgetech releases to the anchor. The ship's crane was used to both raise the releases into place over the anchor, and to lower the anchor outside of the A-Frame where the top of the 3m shot of ½" trawler chain was secured to the vertical chain stopper (Figure 9).
